DEPARTMENT OF TRANSPORTATION

Quality Assurance and Source Inspection

Contract #: 04-0120F4Cty: SF/ALA Rte: 80 PM: 13.2/13.9File #: 1.28**WELDING INSPECTION REPORT****Resident Engineer:** Casey, William**Address:** 333 Burma Road**City:** Oakland, CA 94607**Report No:** WIR-028256**Date Inspected:** 22-Aug-2012**Project Name:** SAS Superstructure**OSM Arrival Time:** 700**Prime Contractor:** American Bridge/Fluor Enterprises, a JV**OSM Departure Time:** 1700**Contractor:** American Bridge/Fluor Enterprises, a JV**Location:** Job Site**CWI Name:** As noted below**CWI Present:** Yes No**Inspected CWI report:** Yes No N/A**Rod Oven in Use:** Yes No N/A**Electrode to specification:** Yes No N/A**Weld Procedures Followed:** Yes No N/A**Qualified Welders:** Yes No N/A**Verified Joint Fit-up:** Yes No N/A**Approved Drawings:** Yes No N/A**Approved WPS:** Yes No N/A**Delayed / Cancelled:** Yes No N/A**Bridge No:** 34-0006**Component:** SAS OBG**Summary of Items Observed:**

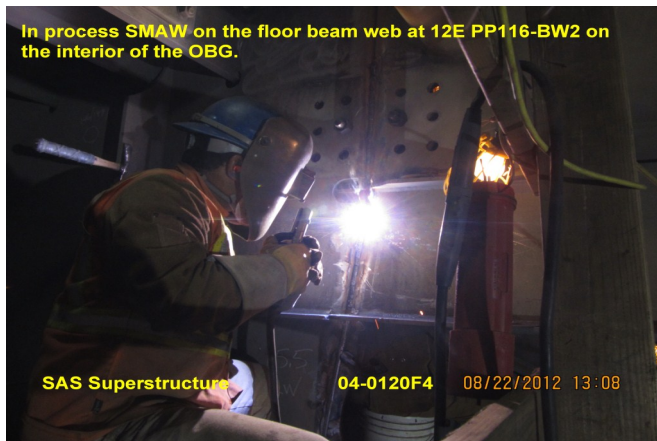
This QA Inspector randomly monitored the in process SMAW of the Beam Web at 12E PP116-BW2 on the interior of the OBG. ABF/JV qualified welder Chris Bowles #9317 was observed grinding the start/stop edges of the work utilizing a small disc grinder. Prior to welding QC Inspector Salvador Merino was observed monitoring the pre-heating of the joint and the parameters as they pertain to ABF-WPS-D1.5-1040A-CU. This QA Inspector verified that the 3.2mm electrodes were stored in an electrically heated thermostatically controlled oven after removal from the sealed containers. The exposure limits of the electrodes appeared to comply with the minimum storage oven temperature of 120 degrees Celsius as per the contract documents. The welding parameters and surface temperatures were verified by the QC inspector's utilizing a Fluke 337 clamp meter to measure the electrical welding parameters. The welder was observed grinding and blending the work utilizing a small disc grinder. This QA Inspector made subsequent observations throughout the shift to monitor quality and noted that the welding at this location was in progress and appeared to be in general conformance with the contract documents.
